SAVE OUR RIVER'S GRASSES *EXPEDITION*

OVERVIEW

PREPARED BY
ST. JOHNS RIVERKEEPER

2023

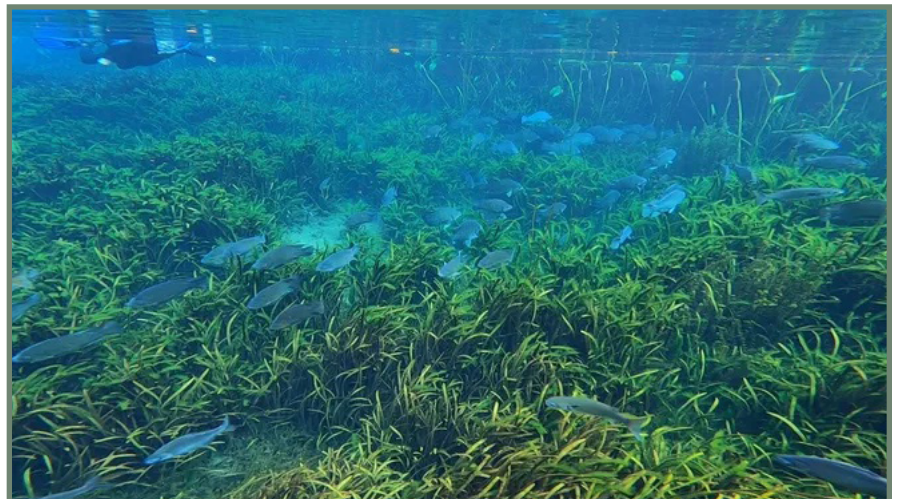
Blue Tilapia with Mullet on the Silver River. Photo was taken during the Florida Springs Institute Silver River Fish Count On July 19, 2021. Florida Springs Institute
