# SAV FIELD LOG

PREPARED BY  
ST. JOHNS RIVERKEEPER

# MAY 2023 *SAVE OUR RIVER'S GRASSES* Background

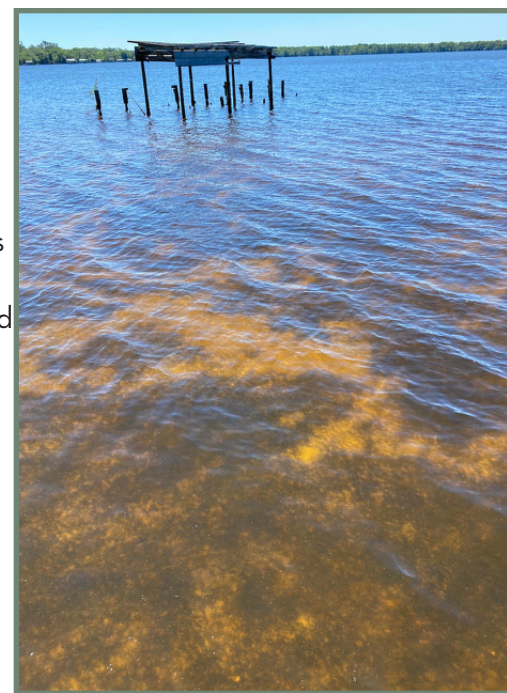
Victor Jackson has lived in Colee Cove for 28 years. His property on the eastside of the St. Johns on Colee Cove has a low wooden bulkhead with several large cypress trees. Victor has witnessed the visible decline of eelgrass behind his home compared to what was once a healthier distribution (see *abundant SAV cover in the April 2020 photo to the right*). The SJRK team found grasses off his shoreline, with an overall canopy height of 1-4 cm.

The SJRK Team also noticed a flailing catfish (approx. 12" in length) in poor health. It has been observed throughout the watershed that catfish populations in particular have been declining at an unusual rate. Following the Spring 2023 tour, the Florida Fish & Wildlife Conservation Commission (FWC) confirmed there had been a fish kill in the area of mostly catfish. Cyanobacteria, or harmful algal blooms, were identified as the cause. **Findings of note for Site 3 include short, stunted grass and a higher pH of 9.29.**

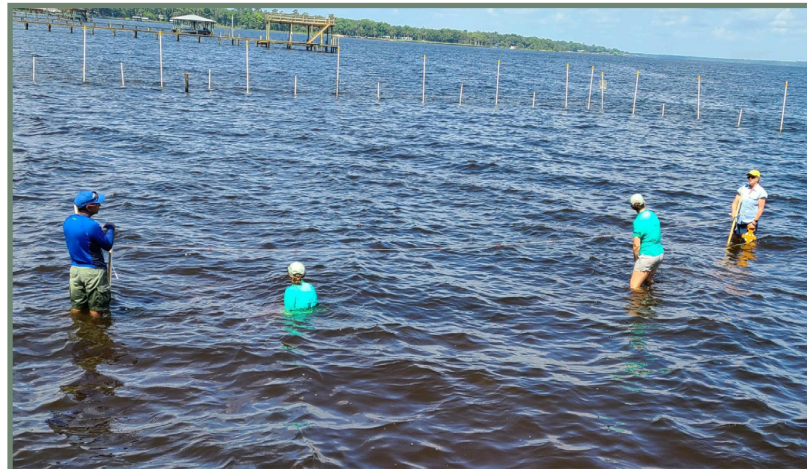
Ray and Lana Bunton have lived on the eastbank of the St. Johns in East Palatka for 47 years. Additionally, Ray's family has lived at that location since 1970. Ray partnered with his friend David Girardin and FWC to fence off nearly three acres of riverbottom through a public partnership to monitor SAV growth while protected from grazers. The shoreline consists of a wooden bulkhead. The SAV team monitored SAV and water quality inside the fenced area as well as outside of the protected zone. Due to SAV presence, the transects here were the longest of any site, at 32 meters inside the fence and 30 meters outside the fence. **Inside the fence, SAV was more dense and its canopy height was taller. Epiphytes were found growing on the SAV, which can block light and hinder photosynthesis. Eutrophic (higher dissolved nutrient concentration) conditions increase epiphyte abundance (Sagan 2007; Stallings, 2015). SJRK documented SAV outside the fence as well, but the grasses were shorter and less dense ([Attachment B](#)).**

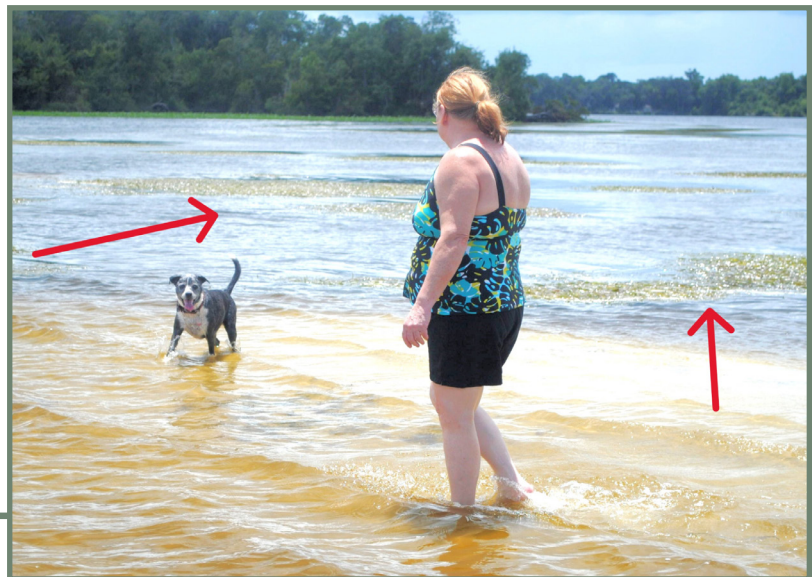
Sam and Lorraine Carr have lived on the eastbank of the St. Johns in Putnam County for 25 years. Their property is bulkheaded and features majestic live oaks that date back to William Bartram days. Sam has witnessed significant loss of eelgrass in his area. The photo to the right is from July 23, 2012 where Sam and Lorraine Carr's dog Trixie can be seen playing in the once-abundant grasses in the sandbar just upstream from Sam's home. An avid fisherman and conservationist, Sam spends ample time on "his river." At the time of the SJRK Team's first site visit, the tide was too high to get an accurate SAV sample.

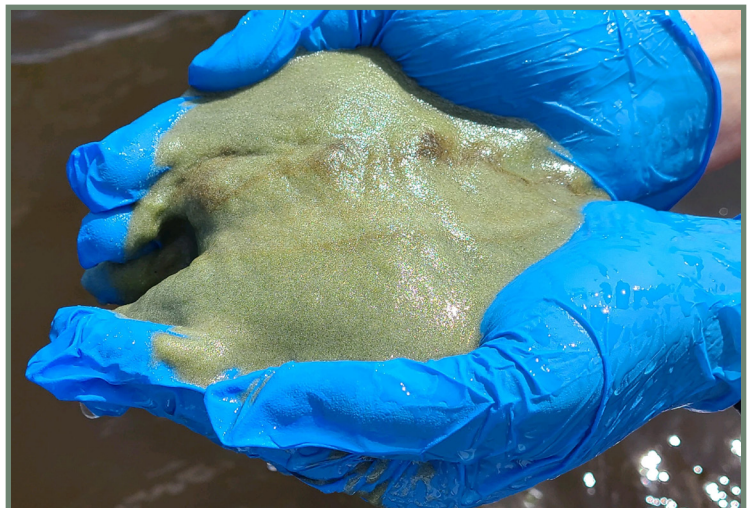
Ken & Jamie Baxley have lived at this property since 2004. The site exhibited a natural shoreline with a gentle slope and cypress trees. The SJRK team took water quality samples and noticed only *Chara sp.* at this site like Sites 10 & 11.. As SJRK exited the water, team members noticed streaks of a potential algal bloom in the vicinity as well as noticeably green sand on the shoreline. Lab reports identified 6 strains of potentially toxic species, but fortunately the toxicity levels at this particular site were low ([Attachment G](#)). It should be noted, however, that toxicity levels can increase drastically in short periods as weather patterns and environmental conditions change. Cyanobacteria can exist both in the sediment and on the surface as a green, filmy substance.
