AUGUST 2023

SAV FIELD LOG

PREPARED BY
ST. JOHNS RIVERKEEPER

AUG 2023 *SAVE OUR RIVER'S GRASSES* Background

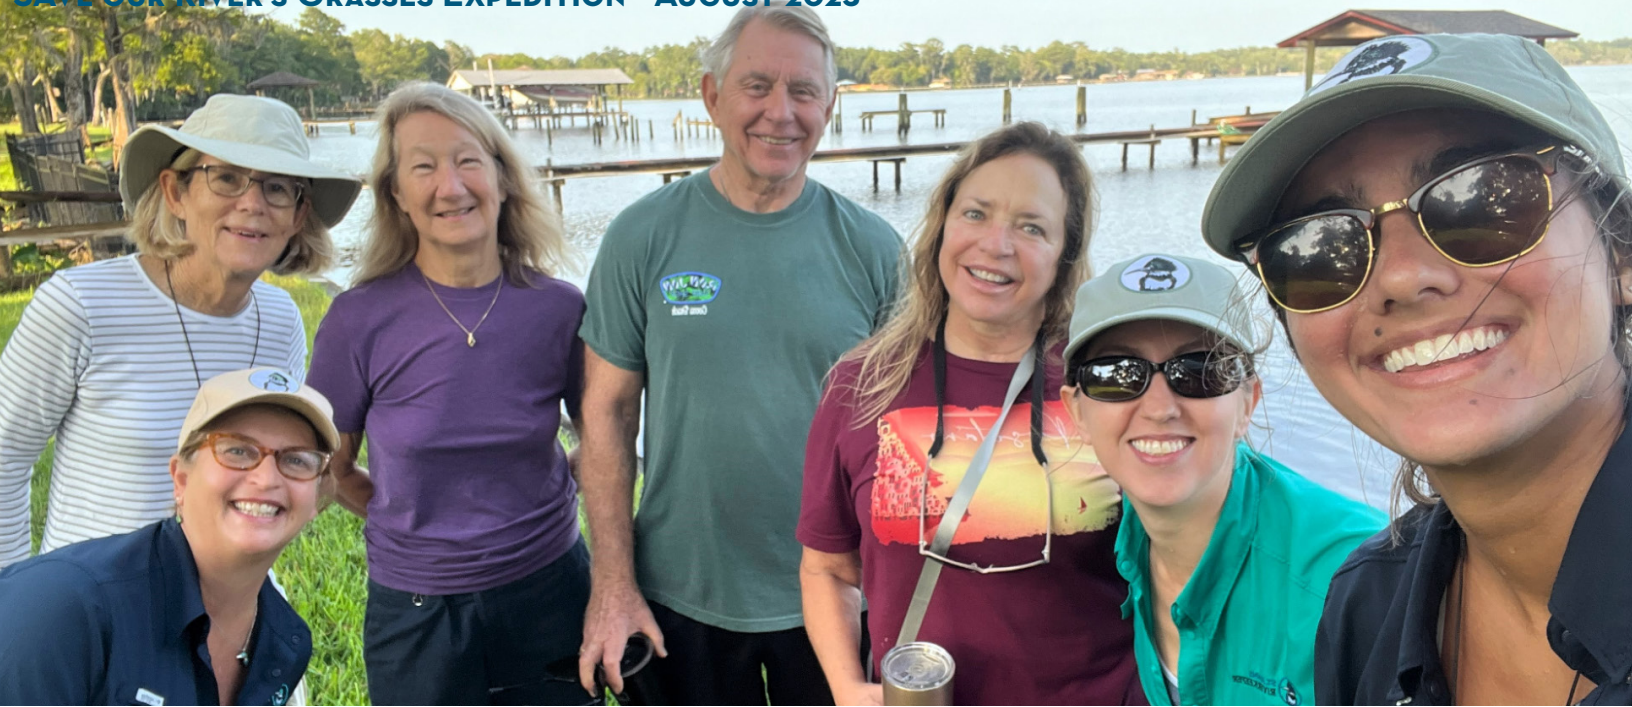
SITE 1 - DOCTORS LAKE

Betsy & Tony Sievert's family has owned their Clay County home located on the northbank of Doctors Lake since 1969. Located just west of the HWY 17 Bridge, their property is bulkheaded and historically had lush SAV and frequent manatee visits. Eelgrass (*Vallisneria americana*, a/k/a "tape grass") used to dominate this area, but none was present at the time of the May 2023 Expedition. SJRK is happy to report that SAV was present during the August field visit. The grass, though short and stunted, was well-dispersed throughout the site area. **The site had lower salinity and higher turbidity during the August visit than the May visit (0.51 ppt vs 6.3 ppt and 2.54 FNU vs 1.77 FNU for salinity and turbidity, respectively).** August's Dissolved Oxygen reading was also slightly lower than May's (73% vs 86.2%). Several neighbors joined us to express their support for and interest in SJRK's efforts to SAVE our river's grasses.

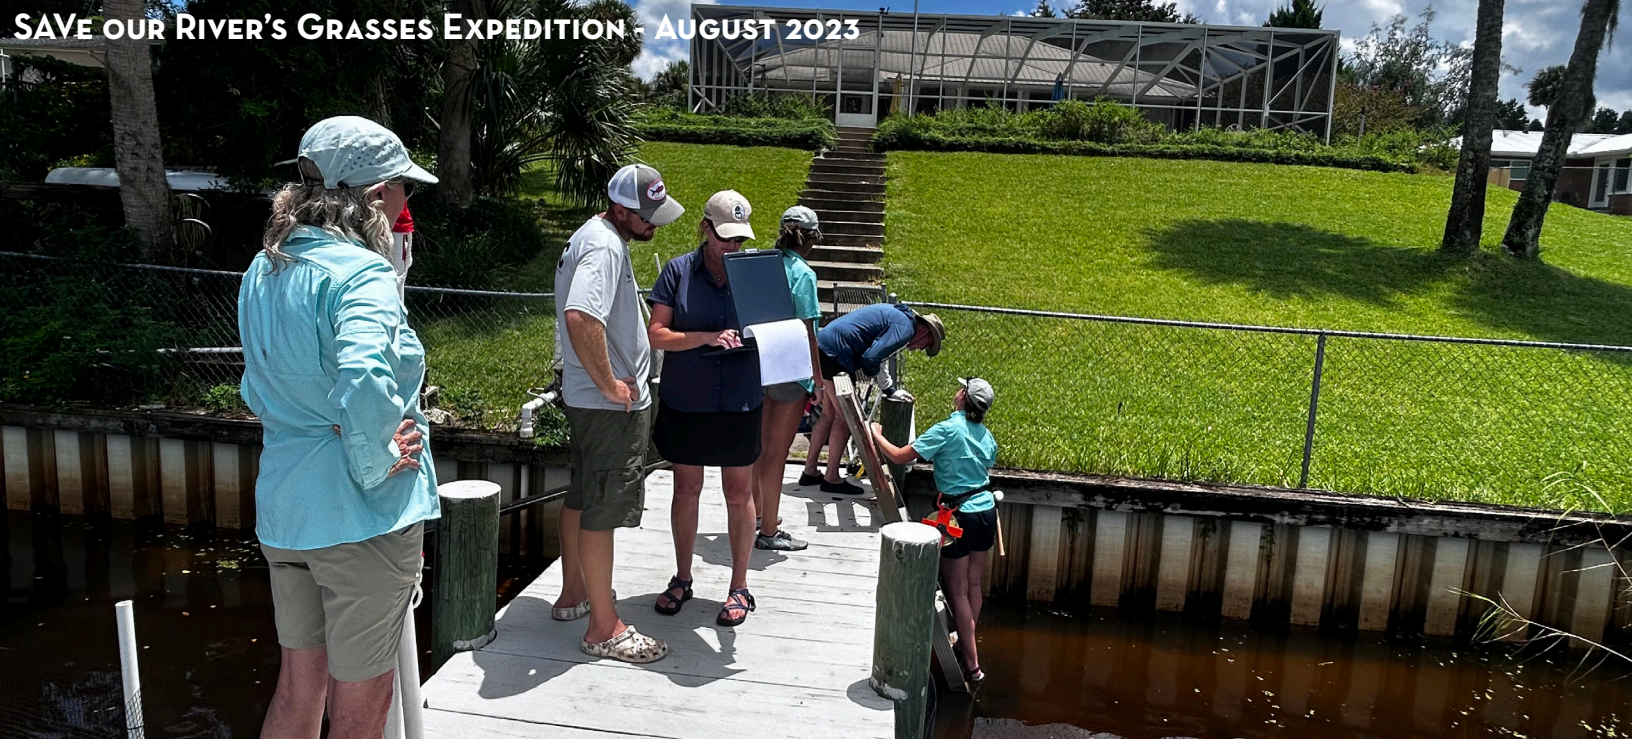
SITE 3 - COLEE COVE

Victor Jackson has lived in Colee Cove for 28 years. His property on the eastside of the St. Johns has a low wooden bulkhead with several large cypress trees. Victor has witnessed the visible decline of eelgrass behind his home over the years. During the August 2023 visit, the SJRK team witnessed abundant coverage of grasses (~99% coverage) on both sides of the dock until visibility was reduced at 200 feet offshore. Unfortunately, both particulate and clumped blue green algae was observed in the water. Out of an abundance of caution, SJRK's SAV Team only took water quality samples, algae samples, and shoreline observations of the SAV due to the potentially toxigenic nature of this algae. Post-visit toxin analyses confirmed the presence of four potentially toxigenic cyanobacteria species from this site. **Findings of note for Site 3 include abundant SAV coverage and algae presence. August's Dissolved oxygen reading was also more normalized compared to May's supersaturated reading (96.6% vs. 139.0%). August's turbidity was also lower than May's (1.20 FNU vs 3.26 FNU).** Photosynthesis can contribute to supersaturation of a water body, potentially bringing the DO above 100% saturation, as Oxygen is produced as a waste product of photosynthesis.

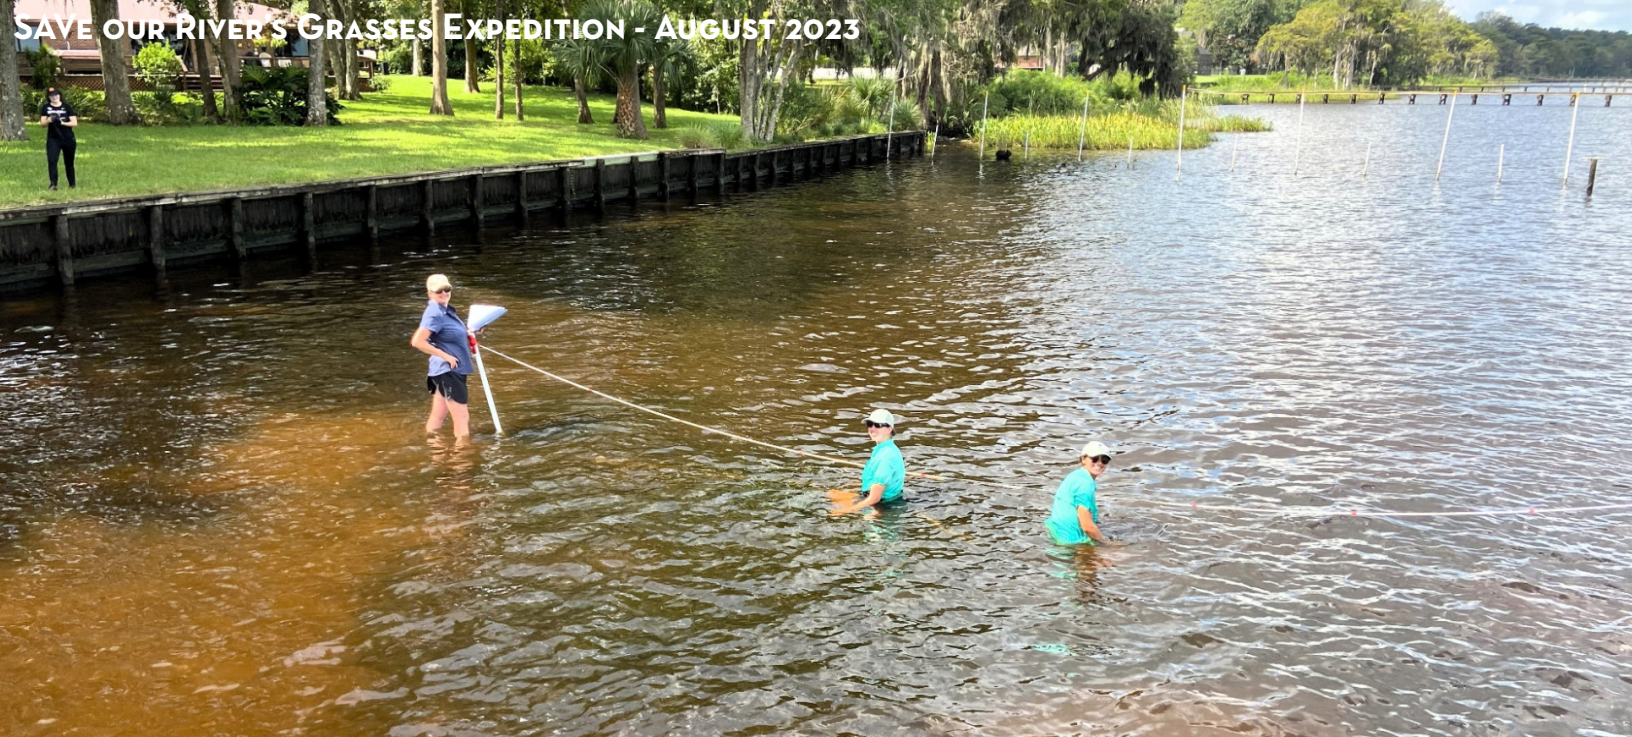
SITE 5 - DANCY POINT

Ray and Lana Bunton have lived on the eastbank of the St. Johns in East Palatka for 47 years. Additionally, Ray's family has lived at that location since 1970. Ray partnered with his friend David Girardin and FWC to fence off nearly three acres of riverbottom through a public partnership to monitor SAV growth while protected from grazers. The shoreline consists of a wooden bulkhead. The SAV team monitored SAV and water quality inside the fenced area as well as outside of the protected zone. Due to SAV presence, the transects here were relatively long at 40 meters inside the fence and 30 meters outside the fence during our August 2023 visit. **Inside the fence, SAV was more dense and its canopy height was taller. The longest canopy height was 25 cm inside the fence. Epiphytes were found growing on the SAV, which can block light and hinder photosynthesis. Epiphytes were present on all SAV, and averaged 33.3% coverage. Eutrophic (higher dissolved nutrient concentration) conditions increase epiphyte abundance (Sagan 2007; Stallings, 2015). SJRK documented SAV outside the fence as well, but the grasses were shorter and less dense ([Attachment A](#)). High dissolved oxygen (supersaturation) was also noted both inside and outside the fenced enclosure, but both areas showed lower DO readings in August than in May. Inside the fence, August DO levels were 112.4%, compared to May's 124.9% reading. Outside the fence, August DO levels were 100.4% compared to May's 115.0%. Inside the fence, May's Chlorophyll-a average readings were higher than August's (6.43mg/L vs 4.39 mg/L). Outside the fence, Chlorophyll-a readings were highly similar between August and May.**

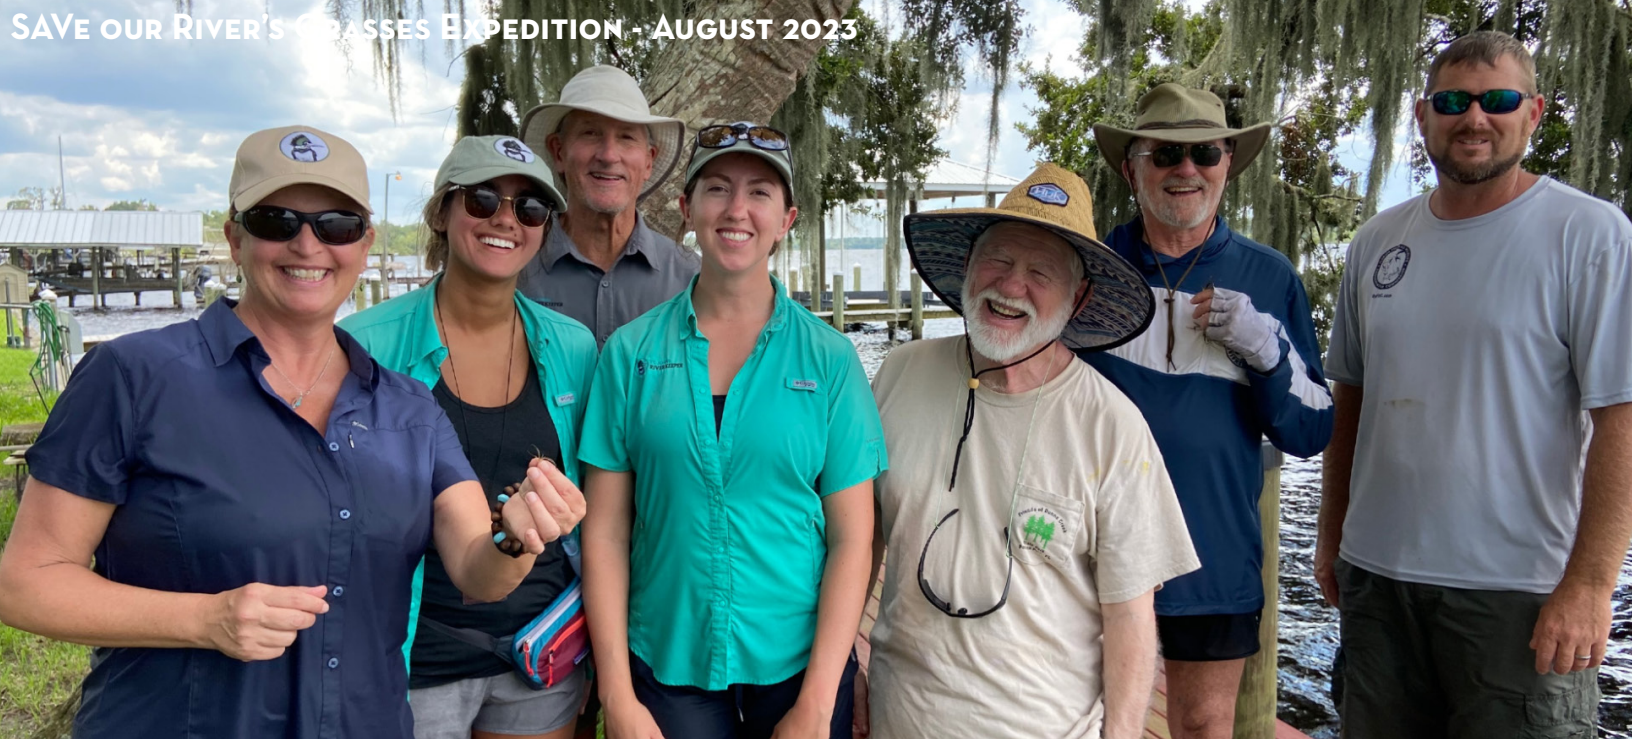
SITE 7 - SAN MATEO B

Sam and Lorraine Carr have lived on the eastbank of the St. Johns in Putnam County for 25 years. Their property is bulkheaded and features majestic live oaks that date back to William Bartram days. Sam has witnessed significant loss of eelgrass in his area. Sam and Lorraine Carr's dog Trixie used to play in the once-abundant grasses in the sandbar just upstream from Sam's home. An avid fisherman and conservationist, Sam spends ample time on "his river." At the time of the SJRK Team's site visit, the tide was too high to get an accurate SAV sample, but grass was felt by our team members and a sample was retrieved (photo, left). Sam's neighbor's home (San Mateo C) was previously used as "Site 8," but SJRK has since determined that combining San Mateo sites "B" and "C" under one site number is most effective. As such, the SAVe Our River's Grasses expedition will now have 12 sites rather than the initial 13.

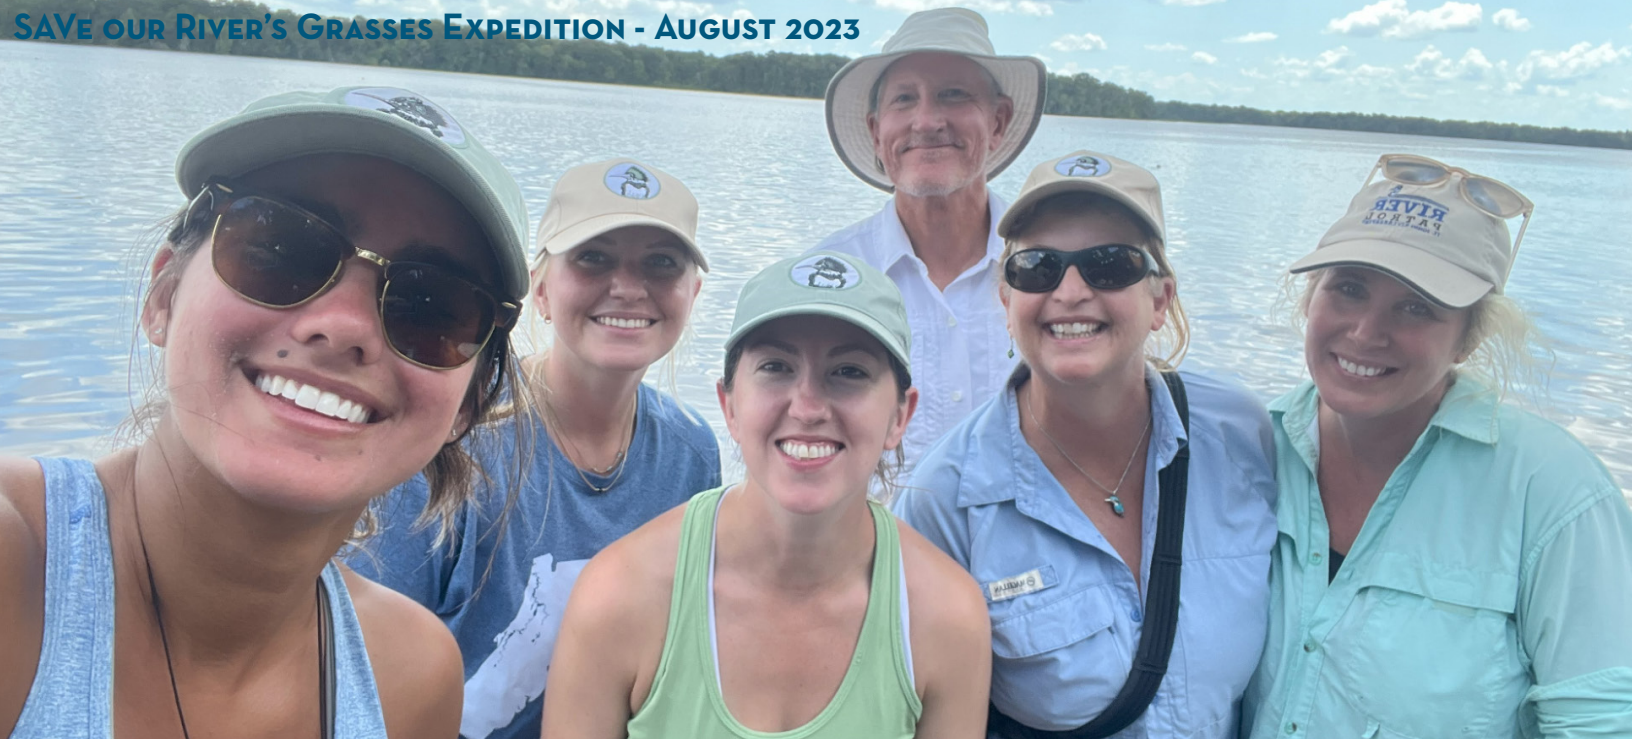
SITE 9 - WELAKA

The Welaka site is located at the home of Jessica and Kevin Finch, who have lived at the property since 2012. The shoreline was natural with cypress trees. The SJRK team once again only found one species of SAV, *Chara sp.*, which is a type of grass-like algae that is growing where healthy eelgrass once did and is commonly referred to as “musk grass” due to its unpleasant odor. This macroalgae is not new to the St. Johns River, but we have found no evidence of *Chara sp.* being the dominant species. *Chara sp.* has a low biomass and thus does not represent an ideal food source for grazers. It is typically found more frequently in Lake George and Crescent Lake. There is evidence to suggest that *Chara sp.* is an early colonizer that appears prior to other SAV species growth, which could be a positive indicator of more diverse and abundant SAV growth in the future. Additionally, green algae was present both on the surface of the water and in the substrate, so the team did not get in the water due to potential toxicity concerns. **Both water and sand samples were collected and analyzed - results indicate that there was one species of potentially toxigenic cyanobacteria present in the water, and no potentially toxigenic species in the sand ([Attachment C](#)).**

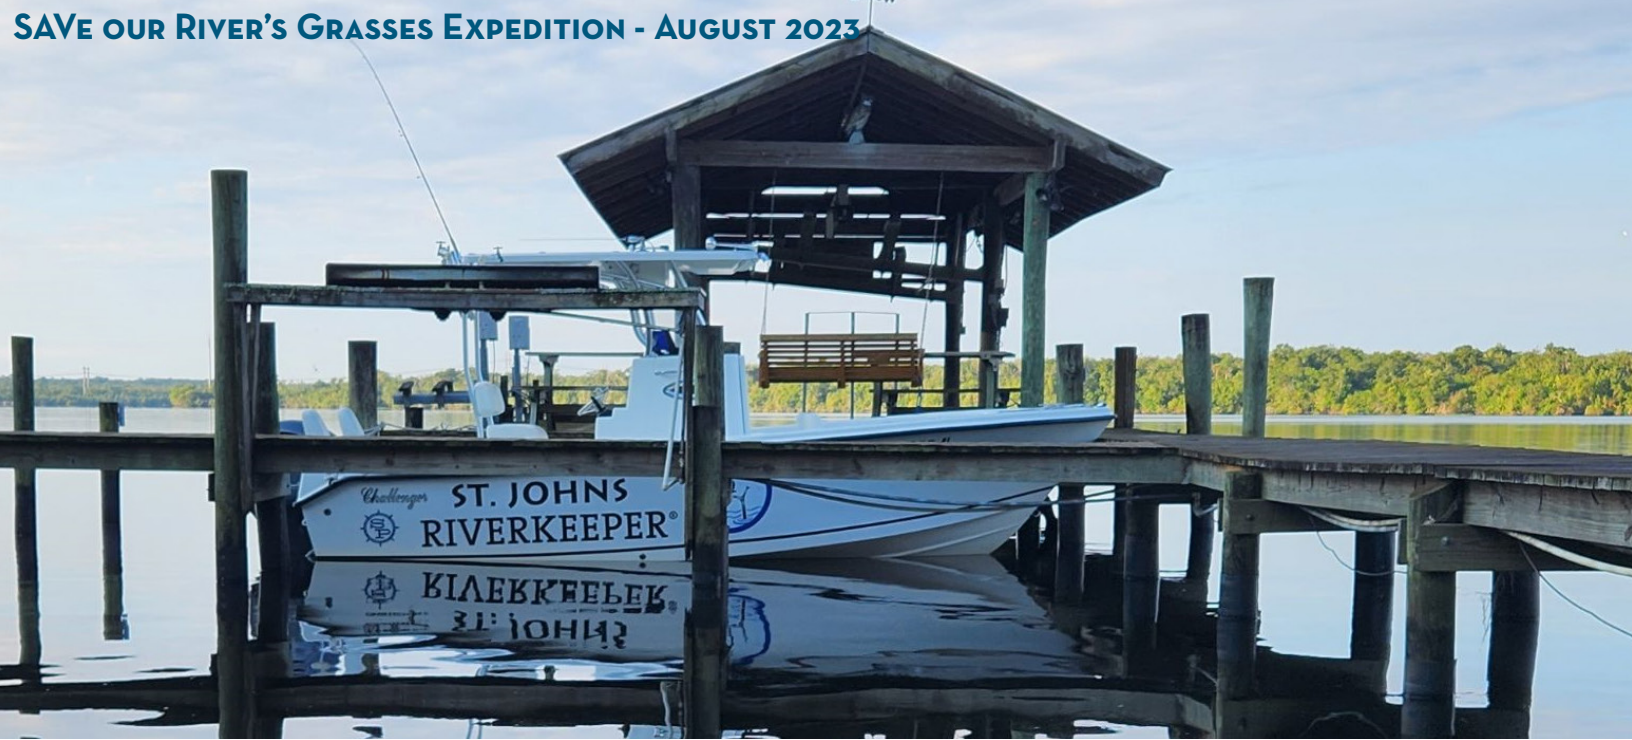
SITE 11 - DRAYTON ISLAND

Ken & Jamie Baxley have lived at this property since 2004. The site exhibited a natural shoreline with a gentle slope and cypress trees. The SJRK team took water quality samples and noticed only *Chara* sp. at this site like Sites 10 & 11. Team members also noticed a potential algal bloom in the vicinity as well as noticeably green sand on the shoreline, so transect and quadrat SAV sampling were not conducted to avoid potential toxins. Lab reports identified 2 strains of potentially toxigenic species in the water. ([Attachment C](#)).
